*Accident
on 25 July 2000
at "La Patte d'Oie"
in Gonesse (95),
to the Concorde,
registered F-BTSC,
operated by Air France*

INTERIM REPORT (15/12/2000)

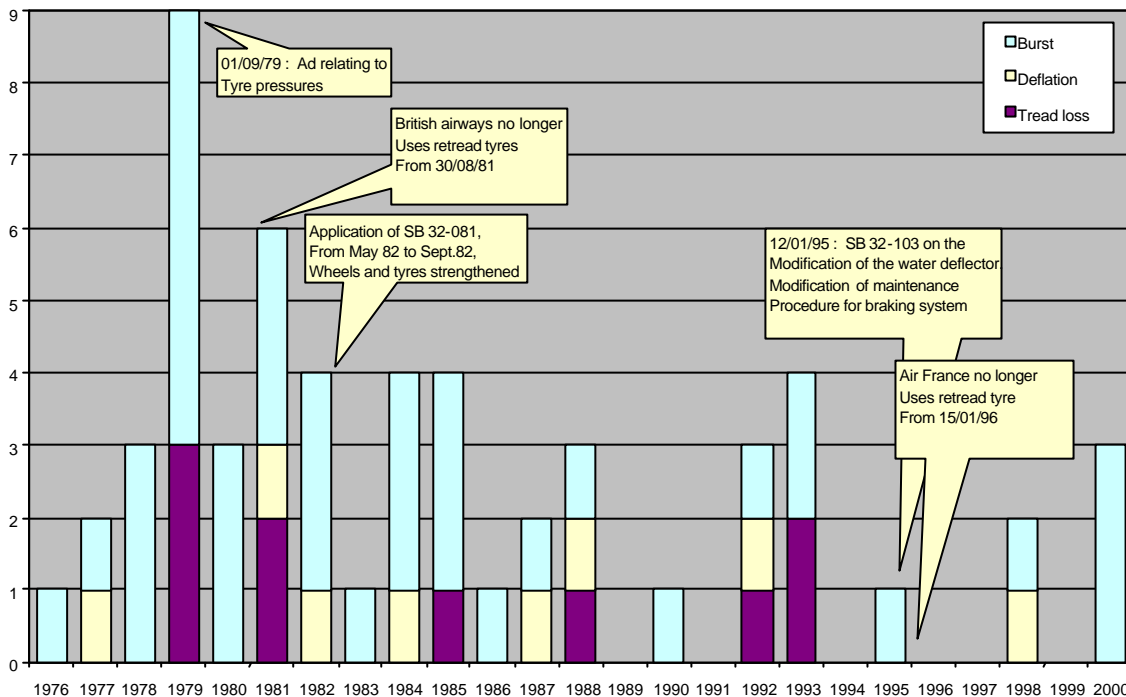
History of events involving tyres on Concorde (AFR ; BA ; confirmed)

- Twelve of these events had structural consequences on the wings and/or the tanks, of which six led to penetration of the tanks.
- Nineteen of the tyre bursts/deflations were caused by foreign objects.
- Twenty-two events occurred during takeoff.
- Only one case of tank penetration by a piece of tyre was noted.
- None of the events identified showed any rupture of a tank or a fire, whether leading or not to a significant simultaneous loss of power on two engines.

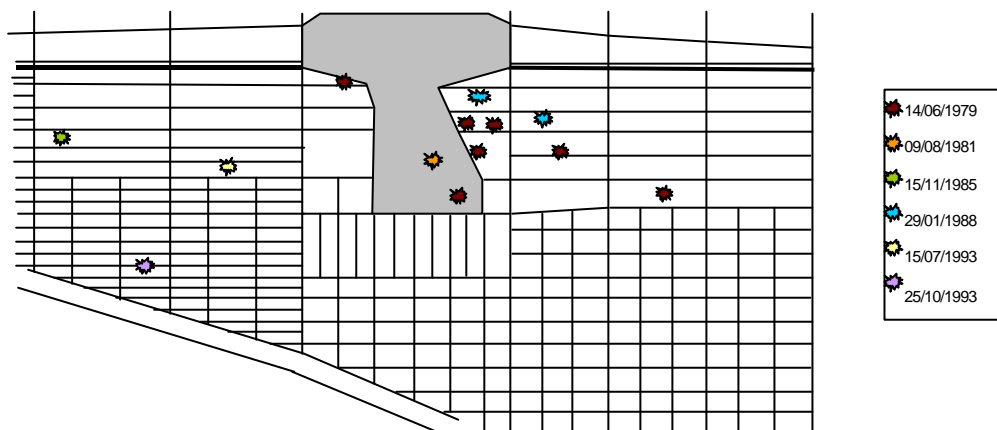
Location of impacts with penetration during the various incidents (right wing and left wing)

15 November 1985: G-BOAB on takeoff from London Heathrow, burst of n° 5 tyre causing damage to the landing gear door. Minor penetration in tank n° 5, probably by a piece of the door mechanism.

15 July 1993: G-BOAF on landing at London Heathrow, burst of n° 4 tyre leading to damage to the gear door mechanism. Tank n° 8 was damaged, probably by a piece of this mechanism.

25 October 1993: G-BOAB during taxiing at London Heathrow, burst of n° 2 tyre leading to damage to the water deflector. Tank n° 1 suffered minor penetration, probably from a piece of the deflector.

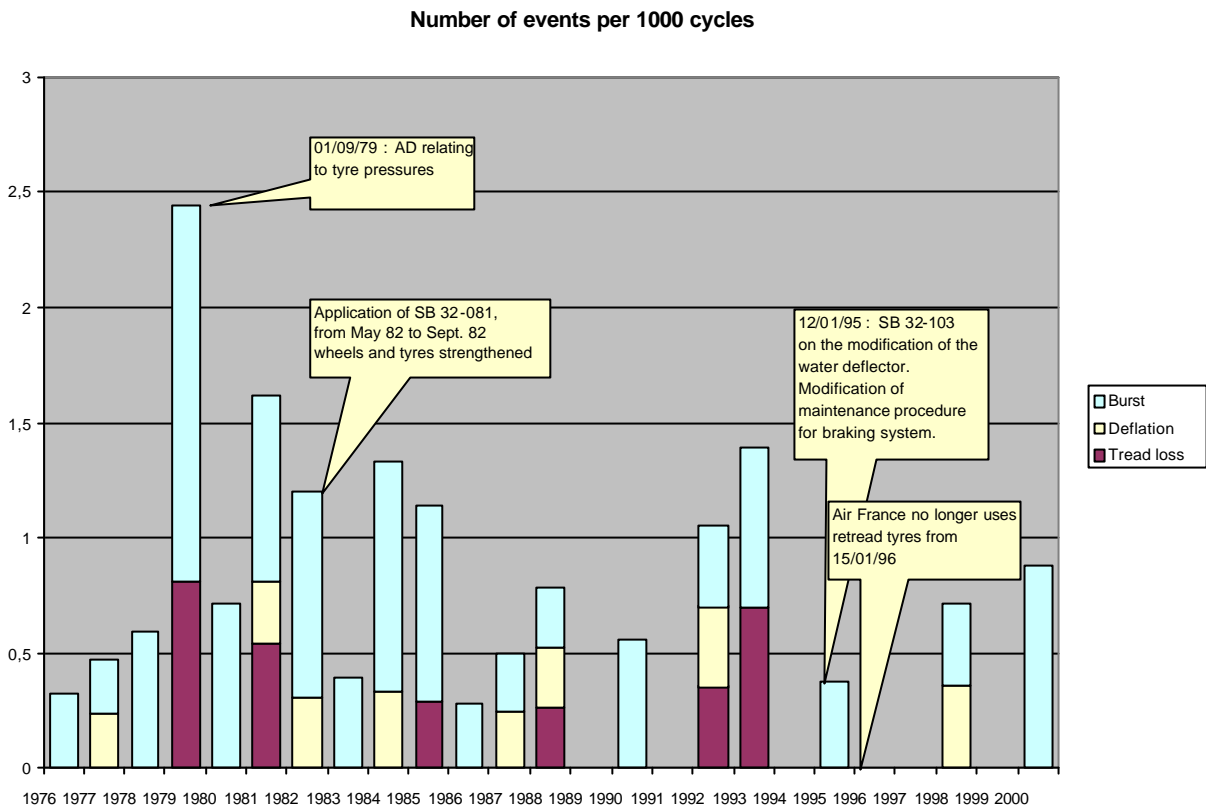
Reduced to the number of cycles, the evolution in the number of events is represented hereafter :

Note : bearing in mind the small number of events taken into account in this statistical approach, evolutions shown in this graph can only give an overall qualitative idea.

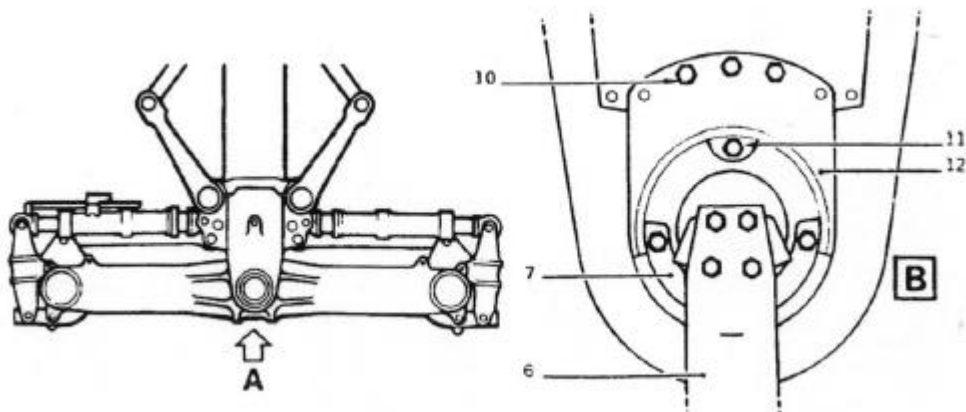
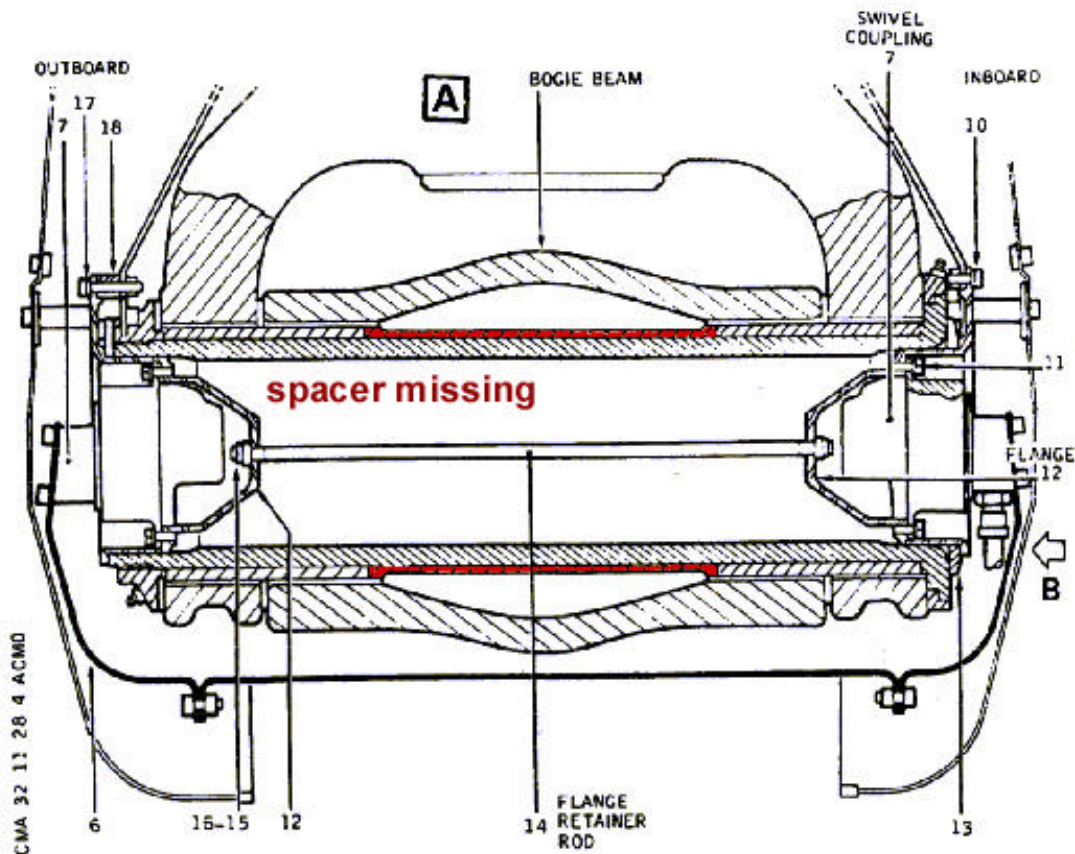
- The left main landing gear was extended and locked at the level of the side-stay. The right main landing gear was severely damaged but clearly identifiable in the extended position. The nose gear was released with its locking pin out.
- The two main landing gear door locks were in the open position.
- The left nose gear door closing actuator was released with movement of 100 mm. The normal course of this actuator is 35 mm when the door is closed and 195 mm when the door is open.
- The main landing gear door closing actuator was broken. An examination of this actuator should allow its movement at the moment of impact to be determined.
- A spacer, which holds two lateral rings in position, is missing from the oleo/bogie coupling on the left main landing gear. This retainer had not been re-installed after the AO1 check performed from the 17 to the 21 July 2000.

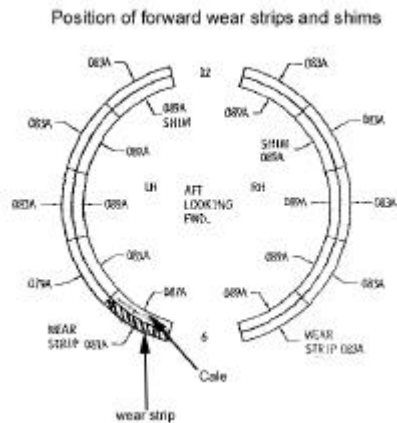
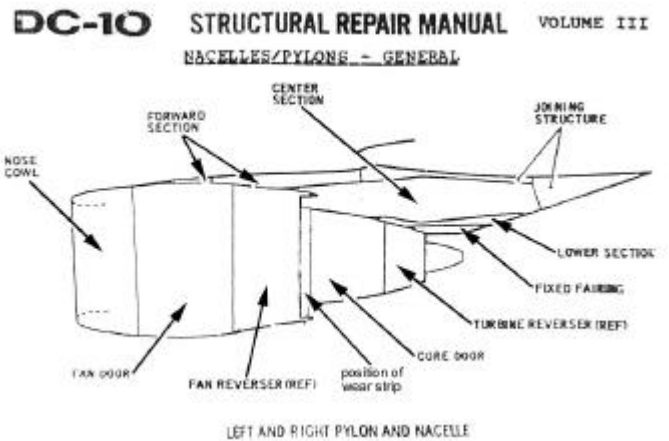
The metal strip found on the runway after the accident (see Preliminary Report, § 12.1.3) appeared to be of a type used in aviation but not belonging to the Concorde. A search was therefore undertaken to identify the aircraft which it could have fallen from. This search was concentrated on the aircraft which had taken off from the same runway after 13 h 00. In addition, work on several types of aircraft led to a belief that the part could be a wear strip from a CF6-50 engine thrust reverser cowl.

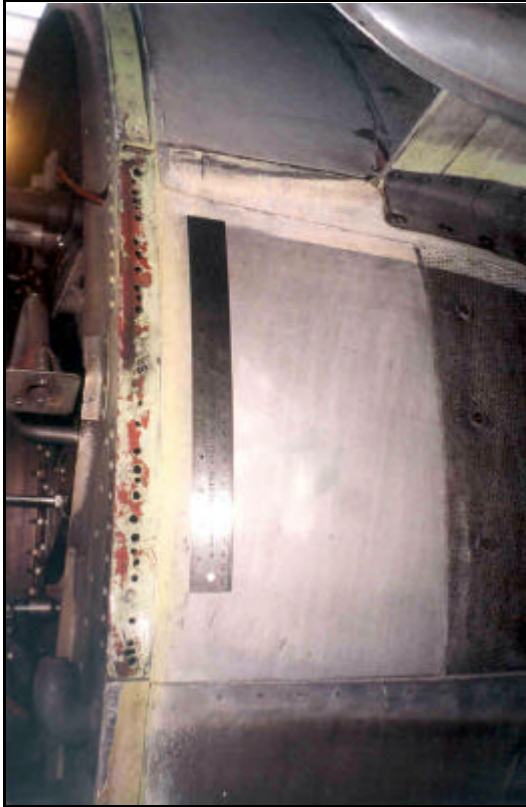
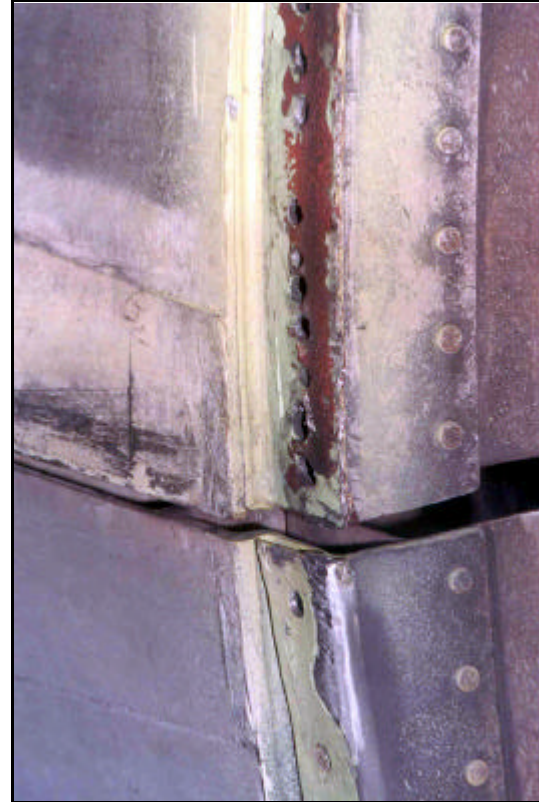
a) Rear reverser cowl structure

- The lower left wear strip, about 44 cm long, was missing. The closed core cowl door normally rests on the front part of the wear strips ;
- The fitting had been painted with green epoxy primer ;
- In the missing part's position, the fitting had been coated with red type RTV106 mastic ;
- There were no traces of RTV 106 on the other parts of the fitting ;
- There were no traces of RTV 106 on the wear strips still in place ;
- There were numerous paint run marks on the fitting and on the wear strips. The paint partially spread over onto the fan cowl door ;
- In the position of the missing part, the fitting still had several rivets in place ;
- the fitting was drilled with thirty-seven holes, some of which had spaces less than twice their diameter between them.

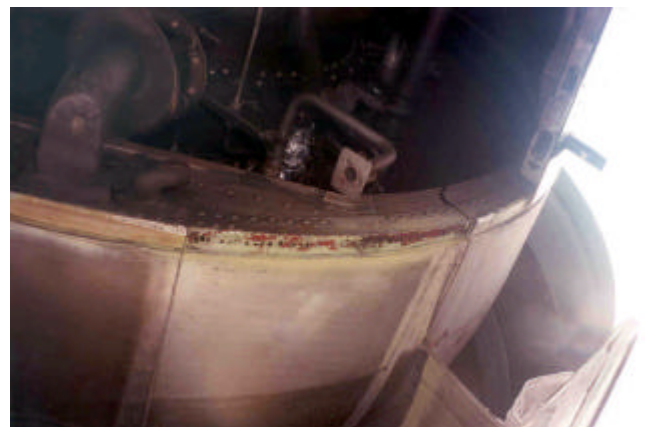
c) Lower right wear strip

- a rivet was missing on the strip. The strip was twisted and allowed play of 6 mm in relation to the fitting ;
- the rivet at the tip was broken off, the part remaining on the fitting prevented the strip from sticking to the fitting, which prevented correct closing of the cowl;
- in comparison with an original part, this strip was too long.

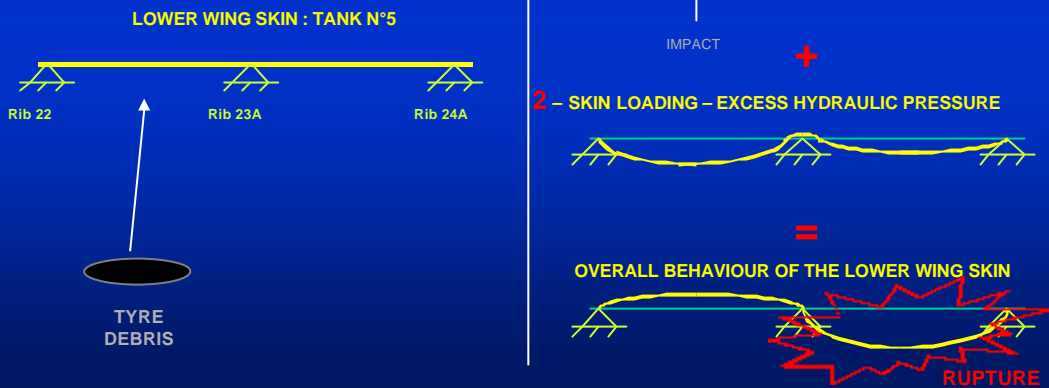
Qualitative approach to the rupture scenario

According to the first results of the simulation performed with the conditions of the 25 July 2000 flight, the rupture of the tank could thus be explained by the conjunction of two phenomena induced by the shock, without penetration, from a large piece of tyre on the tank :

☎ 1st rupture mode : direct penetration by dynamic shearing

☎ 2nd rupture mode : bending effect + excess hydraulic pressure

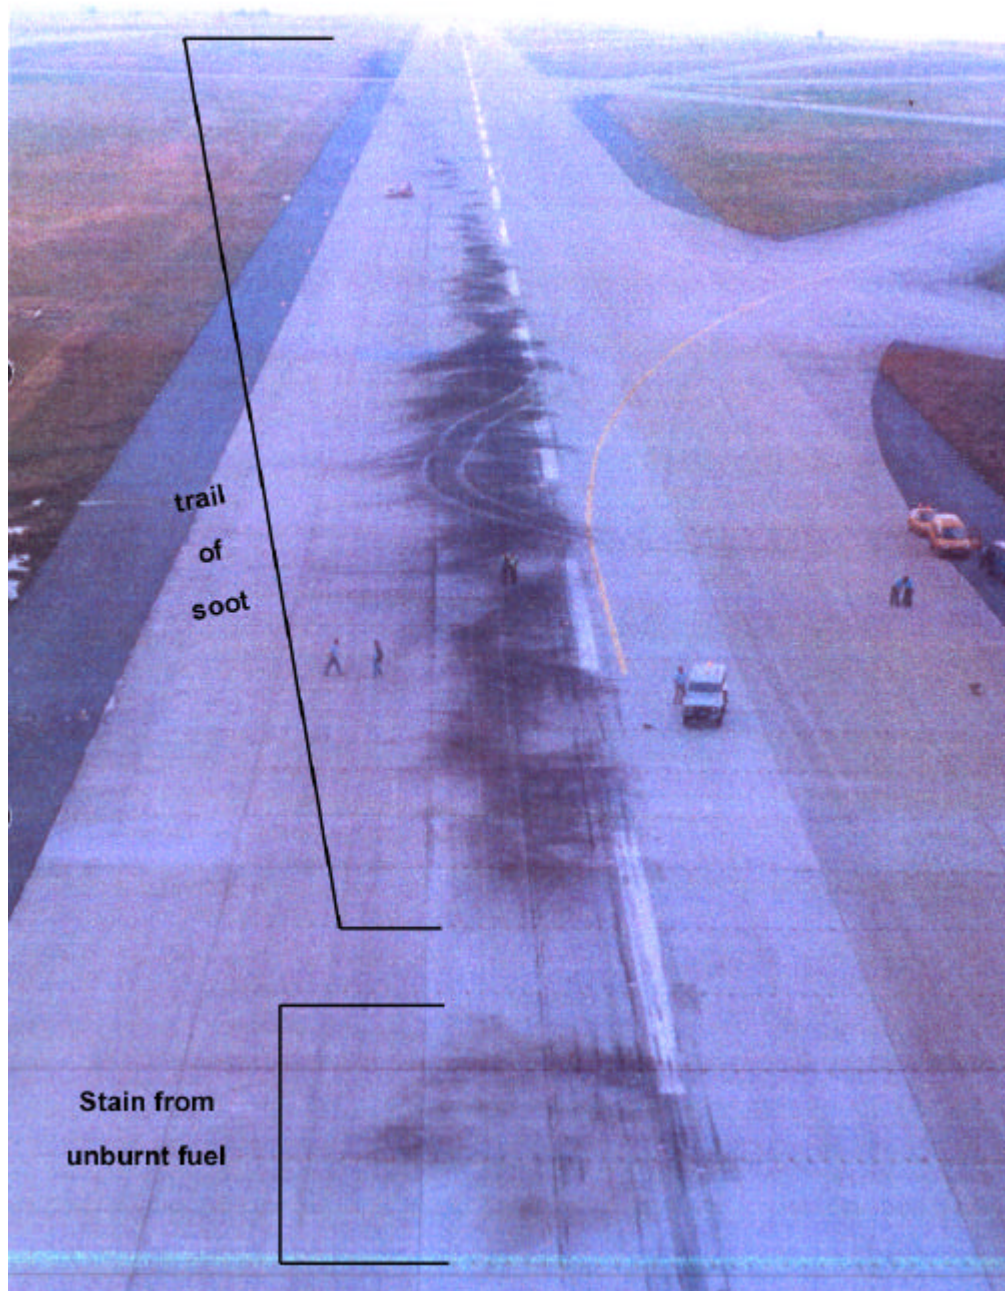
At 14 h 43 min 10 s, a clear, short noise is heard. The speed of the aircraft was 175 kt and the distance from the runway threshold was 1,722 metres. It was from that point onwards that the first parts of the water deflector, pieces of tyre and the metal strip from the DC 10 were found. A slight heading deviation to the left can then be noted at a rate estimated at 1°/s.

At 14 h 43 min 11 s, a very clear change in the background noise is heard and the first tyre marks from wheel n° 2 appeared on the runway. The speed of the aircraft was 178 kt and the distance run was 1,800 metres. The piece of tank 5 was found at this place. A large unburned kerosene stain was identified a few metres further on. Longitudinal acceleration was still nominal and constant (N_x : 0.268 g). In the following second, an incomprehensible word is heard. The speed was 182 kt and the distance run was 1,885 metres. The first traces of soot appeared on the runway. The Captain began to steer to the right and almost immediately began to pull the nose up. Engine thrust and longitudinal acceleration were still nominal.

At around 14 h 43 min 13 s, minimum longitudinal acceleration was recorded (N_x : 0.133 g) and the GO LIGHTS for engines 1 and 2 went off, confirming a loss of thrust on both engines (estimated as slight for engine 1 and high for engine 2). The FO said «watch out » (at this stage of the investigation it is not possible to explain this exclamation). A second more significant heading deviation to the left can be noted, at a rate calculate as 2°/s, probably linked to the yaw caused by the loss of thrust from engines 1 and 2. The controller told the crew that flames were visible behind the aircraft. The nose gear left the ground while a second movement of the rudder pedal is recorded, to counter the yaw movement caused by the loss of thrust from engines 1 and 2. The change in the background noise heard three seconds earlier stops. The speed was 188 kt and the distance run was 2,090 metres.
