*Accident
on 25 July 2000
at "La Patte d'Oie"
in Gonesse (95),
to the Concorde,
registered F-BTSC,
operated by Air France*

INTERIM REPORT (15/12/2000)

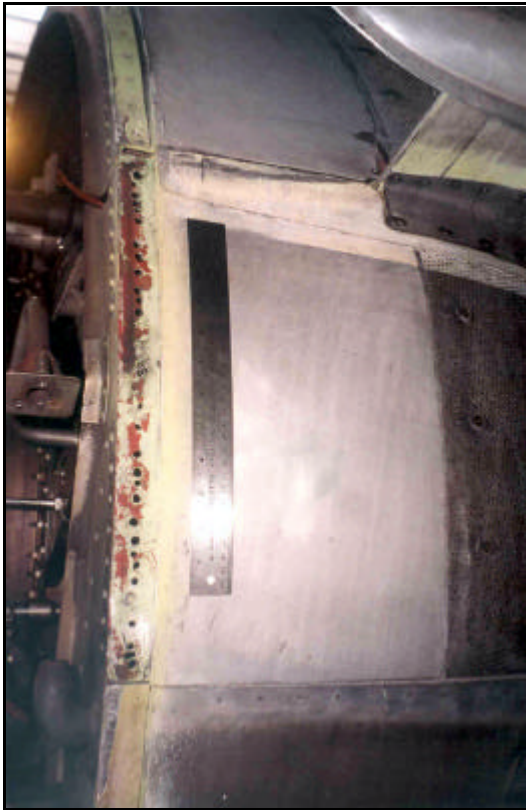
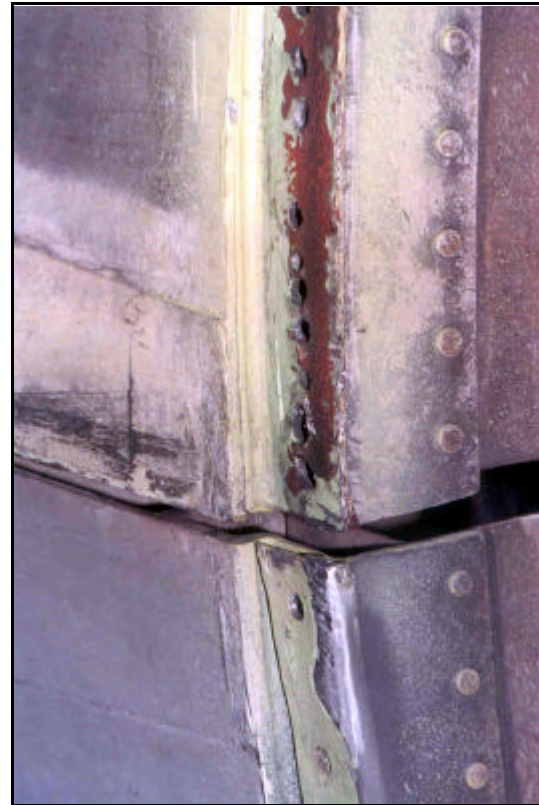
b) Wear strips

- the right wear strips appeared to be original parts made of stainless steel (extruded profile at the tip)
- the left wear strips had been replaced, and do not appear to be original parts made by the manufacturer;
- the spacing of the rivets on the strips in position and their alignment appeared to be correct ;
- the level of wear on the strip adjacent to the missing strip was greatly in excess of the tolerance permitted by the manufacturer.
