*Accident
on 25 July 2000
at "La Patte d'Oie"
in Gonesse (95),
to the Concorde,
registered F-BTSC,
operated by Air France*

INTERIM REPORT (15/12/2000)

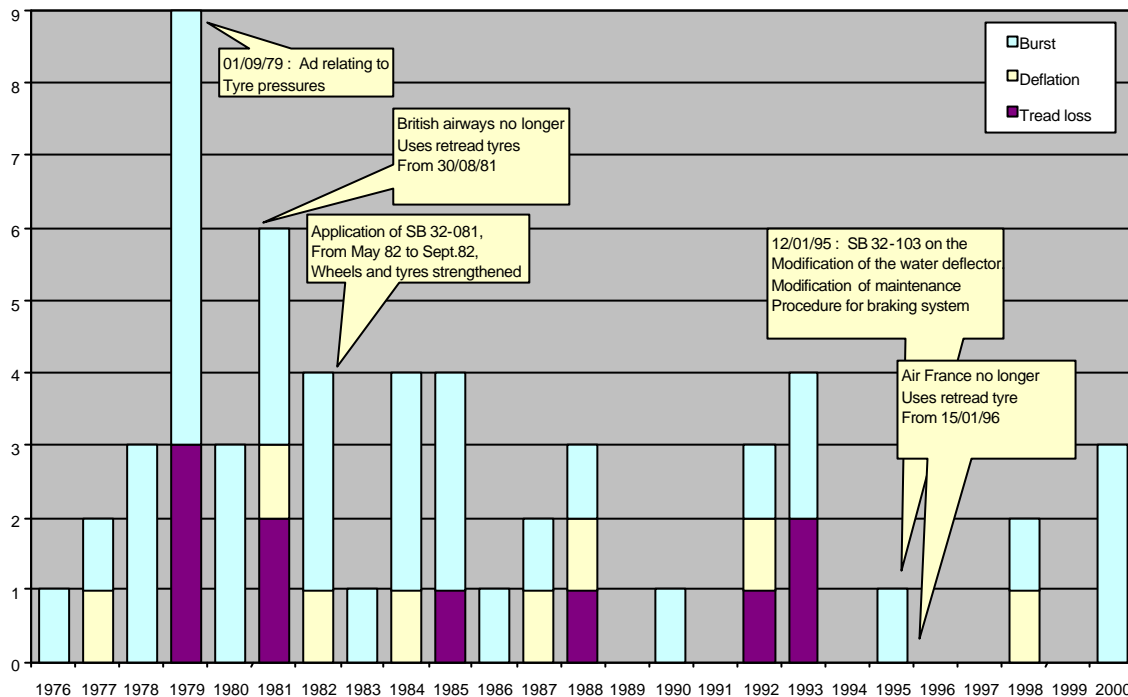
History of events involving tyres on Concorde (AFR ; BA ; confirmed)

- Twelve of these events had structural consequences on the wings and/or the tanks, of which six led to penetration of the tanks.
- Nineteen of the tyre bursts/deflations were caused by foreign objects.
- Twenty-two events occurred during takeoff.
- Only one case of tank penetration by a piece of tyre was noted.
- None of the events identified showed any rupture of a tank or a fire, whether leading or not to a significant simultaneous loss of power on two engines.

Twenty-one other events were notified by a single source, but no reports or detailed information exist for them. No mention was made of damage to the structure or the wings in any of them.
